US&R PROGRAM DIRECTIVE – 2019-001

SUBJECT: US&R Program Directive 2019-001 – Gasoline Powered Equipment Storage

Summary Report of an Incident Within an Incident or Near Miss Event

CO-TF1 Hardigg Case Petrogen Explosion

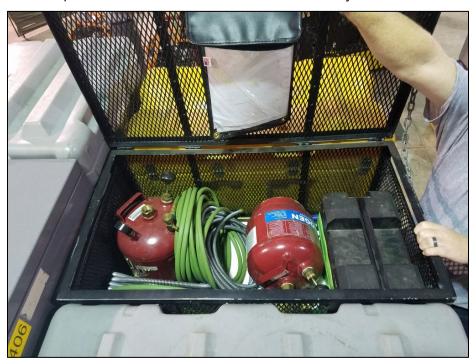
- 5. After fact finding with other task forces CO-TF1 found that TX-TF1 stores their Petrogen in an expanded steel ventilated case (pictured below). CO-TF1 feels that this is a best practice that needs to be sent out to the system.

- 1. Store Petrogen equipment in well ventilated containers.
- 2. Ensure that Petrogen hose lines are purged according to manufacturer's recommendations.

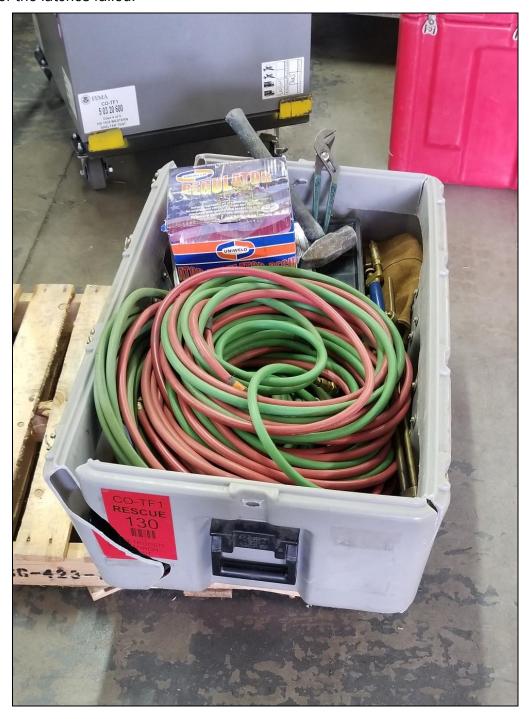
The Hardigg box contained the Petrogen hoses as well as other components, to include the strikers for igniting the torch when in use. The box did not contain Petrogen cylinders. Members reported feeling static shocks from the boxes throughout the training. The fire investigation revealed that the cause of the explosion was the ignition of gasoline vapors within the box, due to either a static shock from dragging the box, or a spark from a striker that may have been jostled within the box. The source of the gasoline vapors was the Petrogen hose lines.

This is the Hardigg case containing Petrogen lines and equipment. Note the failed corners of the case. Note the missing latches that became shrapnel. All of the latches failed.

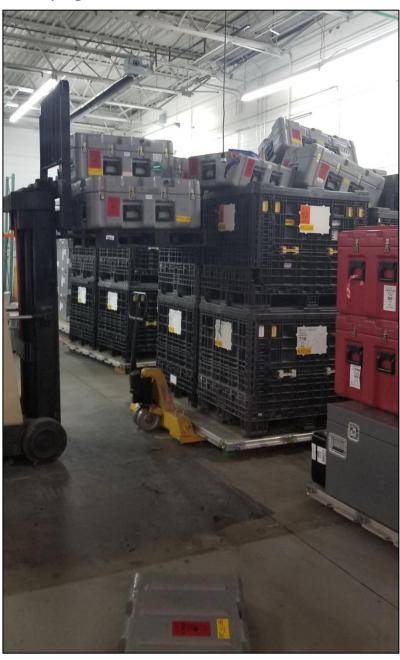
On December 5th, 2018, at 0941, the CO-TF1 Logistics Team was conducting Air Readiness Module training. Two members were working on top of a stack of Hardigg boxes, dragging the boxes from a fork lift to the top of the stack. One of the boxes contained Petrogen hoses and equipment and when it was dragged it exploded, causing a significant laceration on one member's forehead. The cause of the laceration was a metal latch that separated from the box during the explosion and the member required ambulance transport to the hospital. The other member sustained minor facial abrasions and burns and did not require medical treatment.

The members were working on top of this ARM pallet. In the photo the damaged Hardigg box is right behind the power cable that is hanging from the ceiling. Note the landing place of the box top at the bottom of the photo. The other boxes on top of the pallet are jumbled because they were quickly set aside to assist the injured member off the top of the stack. The stack height was approximately eight feet.
